# Proposals for Hetton Lyons Country Park

# Link Together Project Hetton Lyons

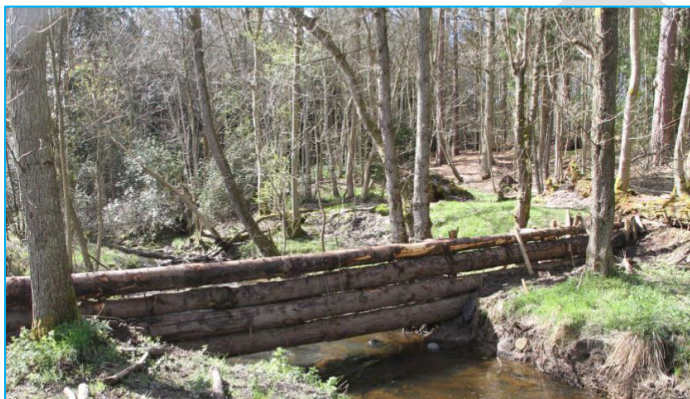
#### Large woody debris

**Large Woody Debris** - also referred to as LWD, is typically described as fallen trees, logs, and branches that are at least four inches wide and six feet long. These cost-effective features are designed not to impede low/moderate flows but help water onto the floodplain during high flow events. Leaky design (that doesn't try to contain the power of water) and heavy-duty steel fixings prevent damage and dislodgement.

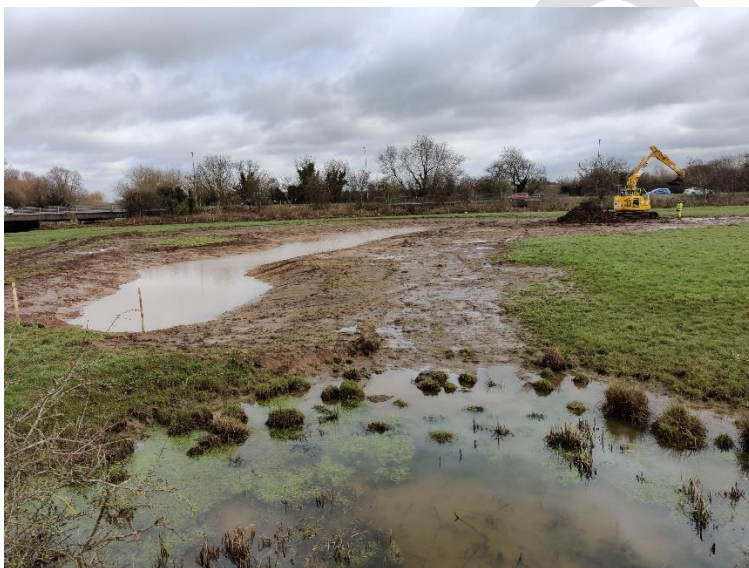
### Wetland scrape

**Wetland scrapes** can help to create additional 'temporary' flood storage in floodplains. They can also trap sediments and encourage infiltration to groundwater.

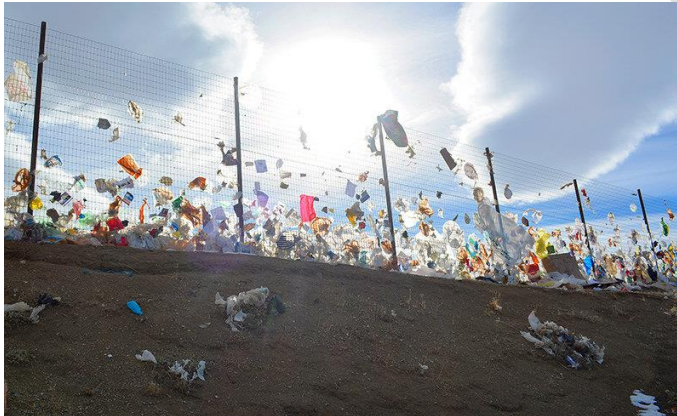
### Fence to intercept litter

**Windblown litter** is intercepted by carefully placed **fencing**. The resultant litter is easier to collect and prevents watercourses becoming blocked.

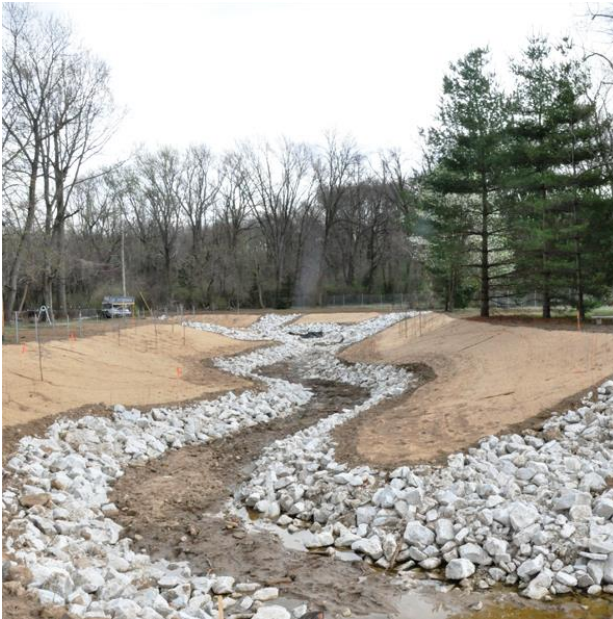
### Channel aggradation

**Channel aggradation** means the replacement of river gravels which have been lost due to channel scour or changes in channel geometry. Can lead to dramatic improvements in river process, form and function.
