# Proposals for Red Burn at Rainton Meadows

# Link Together Project Redburn

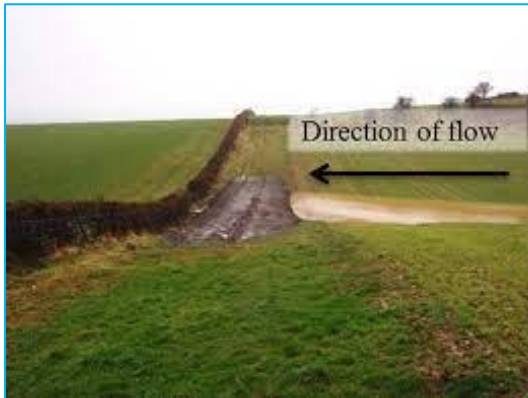
#### Earth Bund

**Earth Bund** - A sloped embankment or bund constructed from earth. They are designed to withhold water flowing over land during high rainfall events and prevent flooding. They can also intercept pollutants. They are engineered to limit outflow and designed for longevity with hidden structure and pipes.

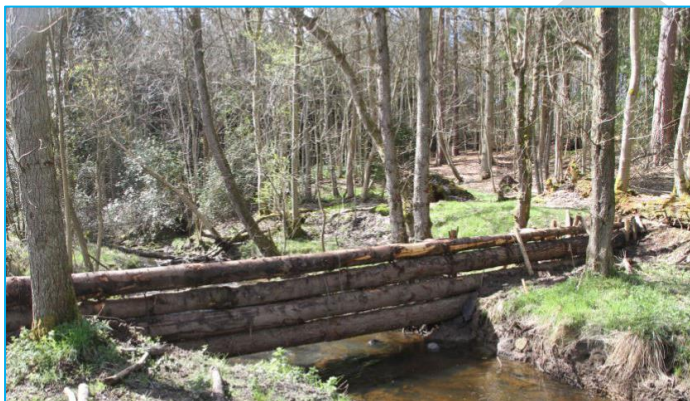
#### Large woody debris

**Large Woody Debris** - also referred to as LWD, is typically described as fallen trees, logs, and branches that are at least four inches wide and six feet long. These cost-effective features are designed not to impede low/moderate flows but help water onto the floodplain during high flow events. Leaky design (that doesn't try to contain the power of water) and heavy-duty steel fixings prevent damage and dislodgement.

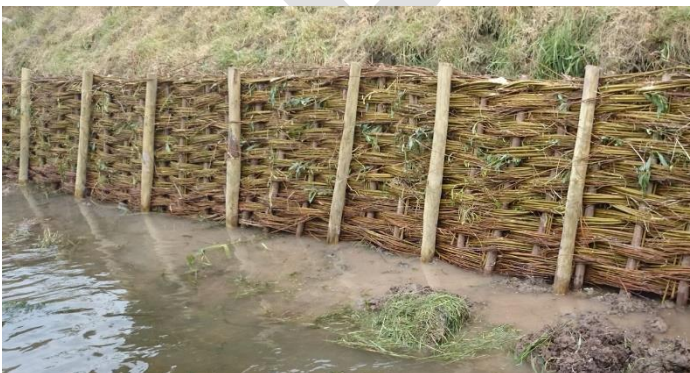
#### Green bank protection

**Green bank protection** is used to protect banks from erosion by reducing the erodibility of earth banks. Willow weaves, fixed brush, driven posts with fixings create a low risk, cost effective habitat improvement.

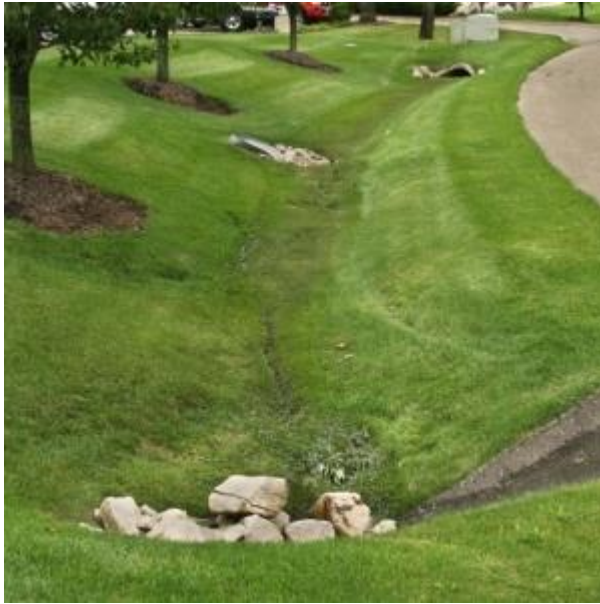
### Drainage improvements

**Drainage improvements** help convey surface water to areas of temporary flood storage. Gravel drains, pipes, swales can intercept surface water, improve access and reduce the risk of pollution downstream.

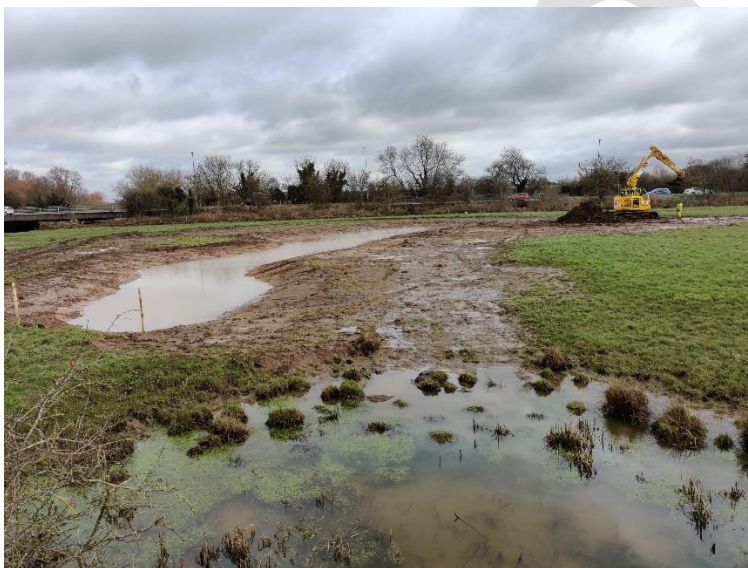
### Wetland scrape

**Wetland scrapes** can help to create additional 'temporary' flood storage in floodplains. They can also trap sediments and encourage infiltration to groundwater.

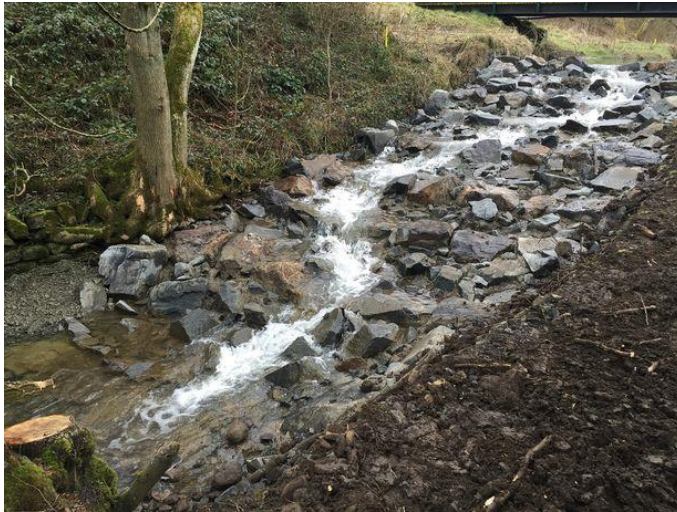
### Fish passage easement

Engineered solution to facilitate fish passage at man-made in river obstructions. Simple **fish easements** in a 'close to nature' style can be engineered with block stone or fixed baulks or beams can modify flows to allow improved river function.

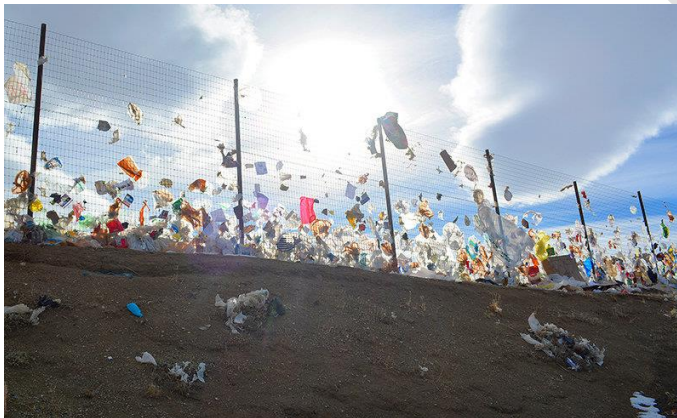
### Fence to intercept litter

**Windblown litter** is intercepted by carefully placed **fencing**. The resultant litter is easier to collect and prevents watercourses becoming blocked.

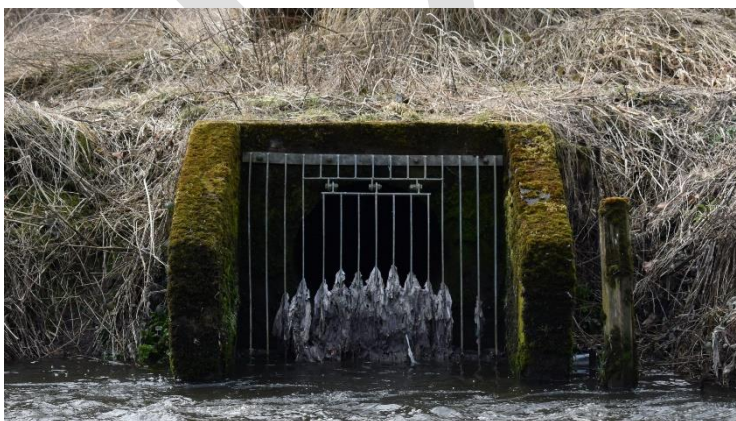
### CSO

**Combined Sewerage Overflow (CSO)**. Hard engineered structures that require maintenance and can lead to bank and bed scour. Can be protected with green engineering. In stream steps can become a barrier to fish and sediments.

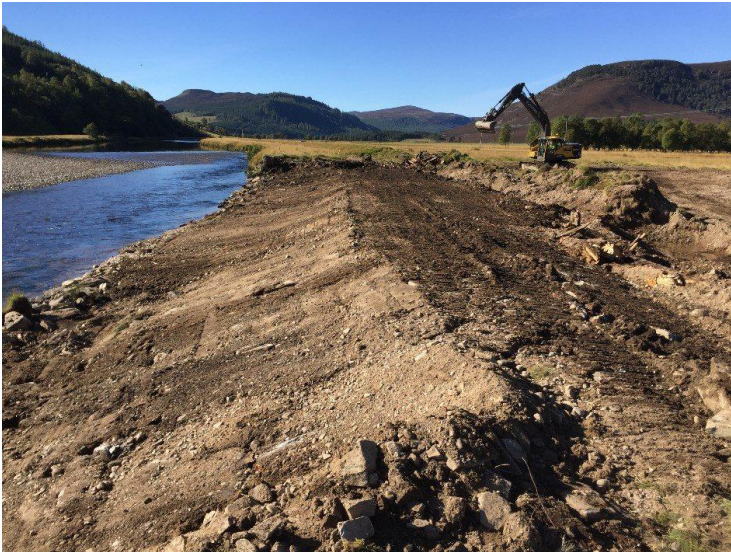
### Re-meander

**Creating a new meandering course or reconnecting cut-off meanders**, therefore slowing down the river flow by reducing gradient and providing additional flood storage. Reconnection to floodplain is possible.

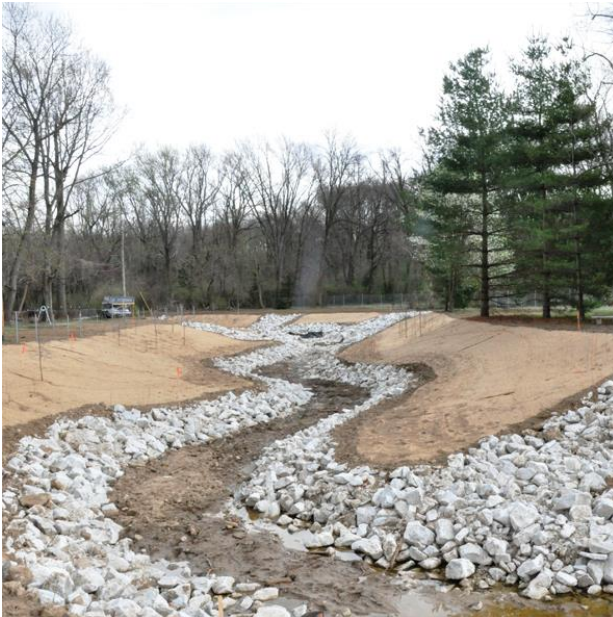
### Channel aggradation

**Channel aggradation** means the replacement of river gravels which have been lost due to channel scour or changes in channel geometry. Can lead to dramatic improvements in river process, form and function.

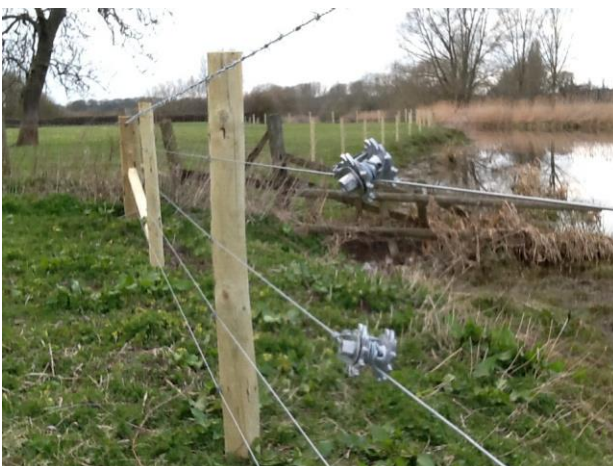
### Livestock fencing

**Livestock fencing** from watercourses directly benefits water quality and encourages beneficial riparian vegetation i.e. bank habitat.

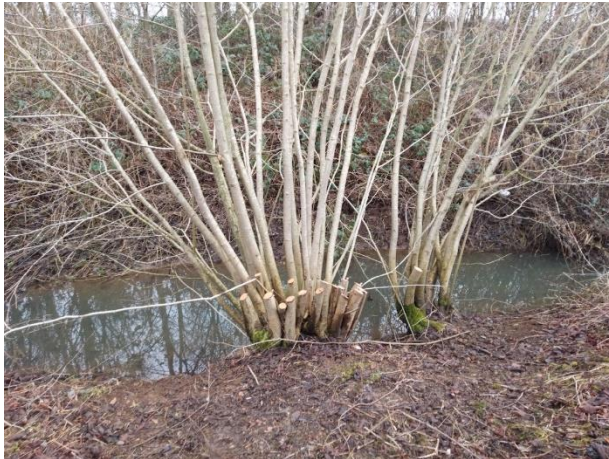
### Tree coppicing

**Tree coppicing** is a traditional technique which benefits watercourses which are overshadowed. The coppicing of bankside trees increases the longevity and health of these features, provides valuable habitat and habitat corridors in river valley and wetland landscapes. In the right location selective coppice can help stabilise river and ditch banks.

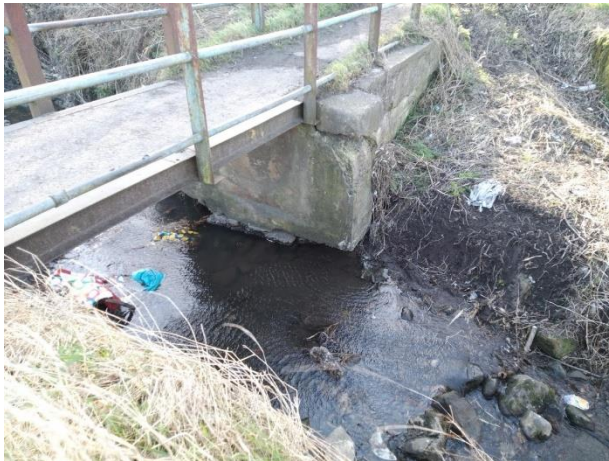
### Stone bridge protection

Where bed scour and channel incision expose foundations, **stone and/or green engineered protection** around footings and banks can reduce/reverse scour by working with natural processes common to all hard structures in stream.

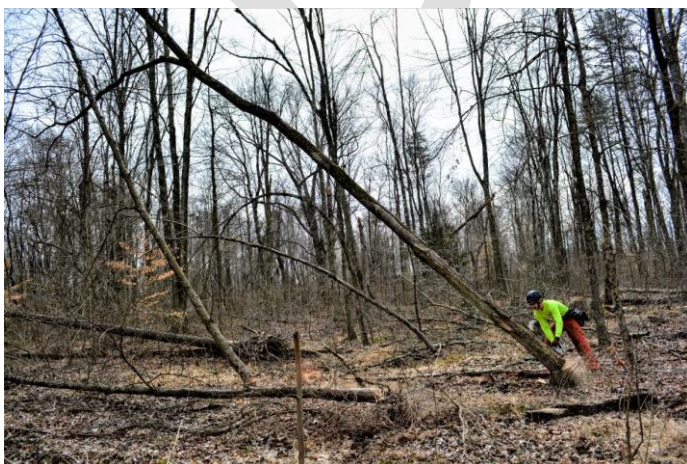
### Tree thinning

As well as benefitting woodlands, **thinning** can allow light into tunnelled sections of river. Arisings can be utilised for in river works.
