## Greenspace 8- Hetton Bogs

### 1.0 Introduction

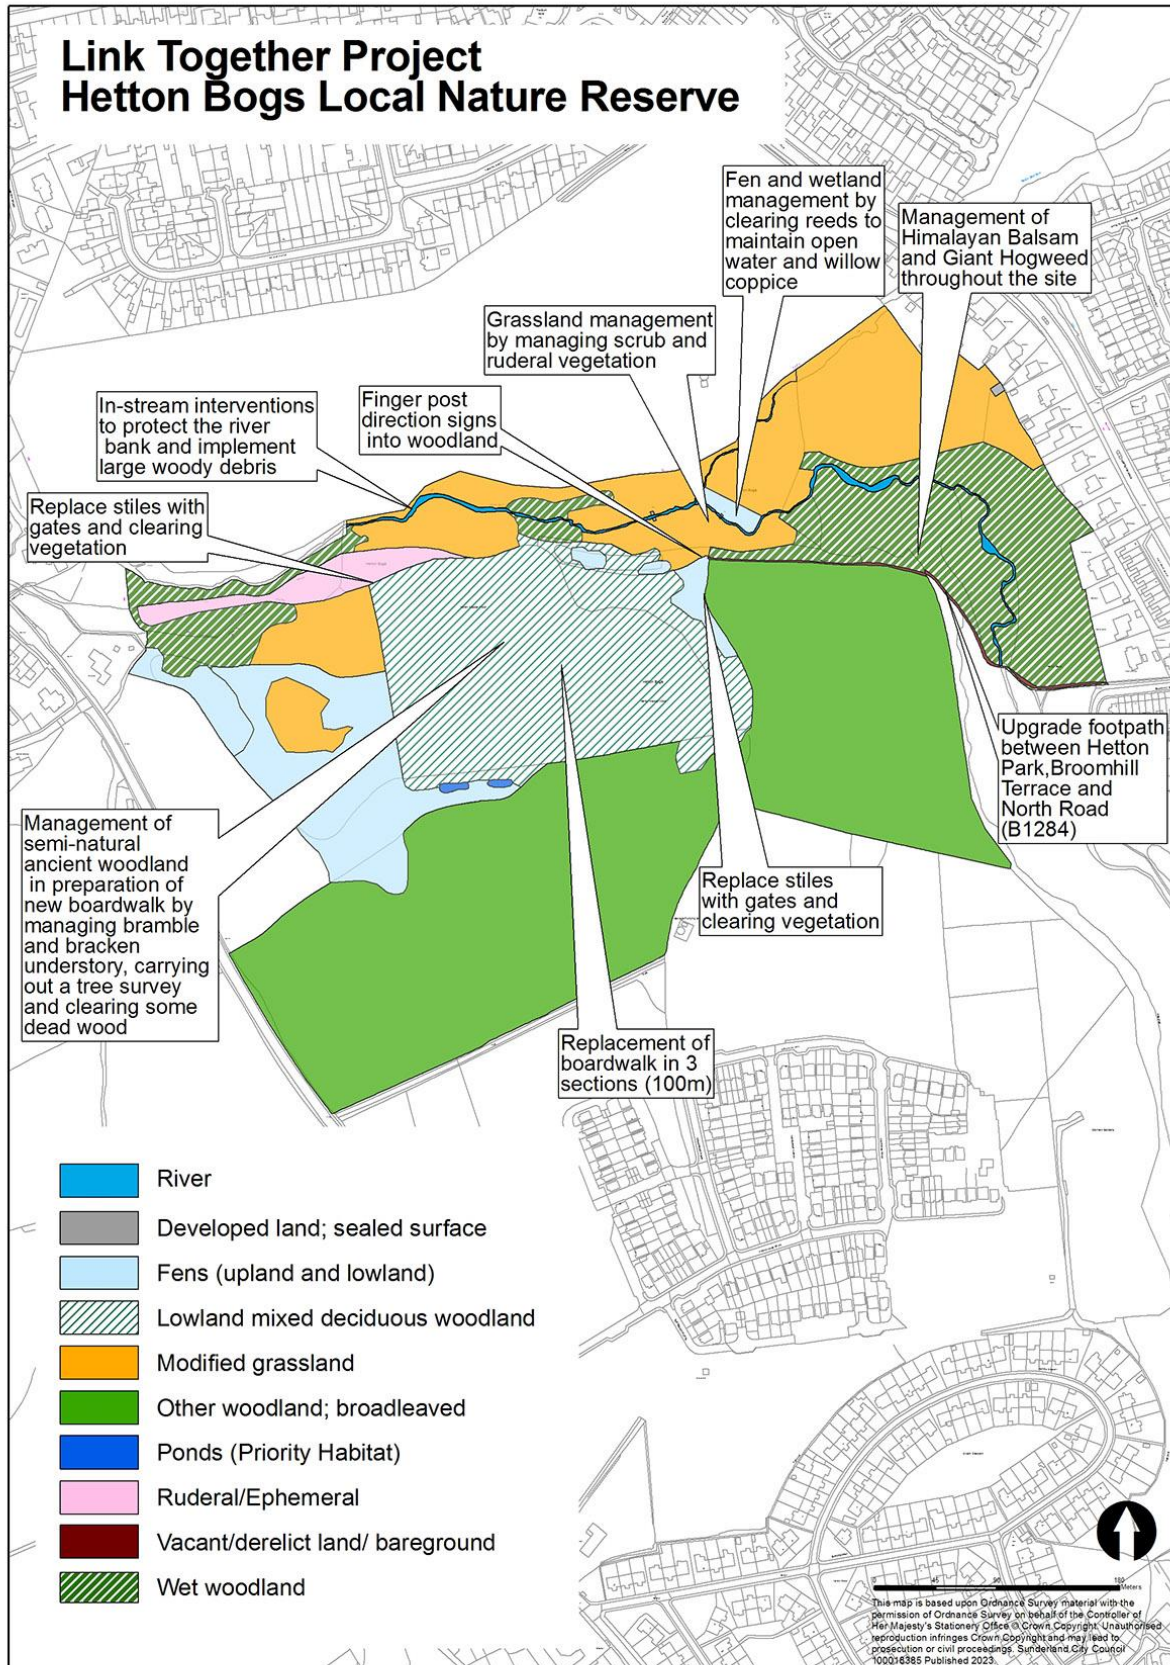
Locations of proposed works are shown in the map below.

### 11.1 Habitat Management at Hetton Bogs:

- To maintain banksides at Hetton Burn and maintain good habitat for water vole;
- To manage and reduce the presence of Himalayan Balsam;
- To enhance areas of grassland;
- To enhance areas of fenland.

### 11.2 Access and Interpretation:

- To substantially upgrade the footpath through Hetton Bogs in order to capture and support usage increases arising from adjacent housing development;
- To maintain through signing in accordance with the standards expected on definitive PROW ('easy to find and follow and use');
- To improve access into and through semi-natural ancient woodland.
